# **Navajo Abandoned Uranium Mine**

## **Site Screen Report**

### **Cov068 AUM Site**

**March 2010**

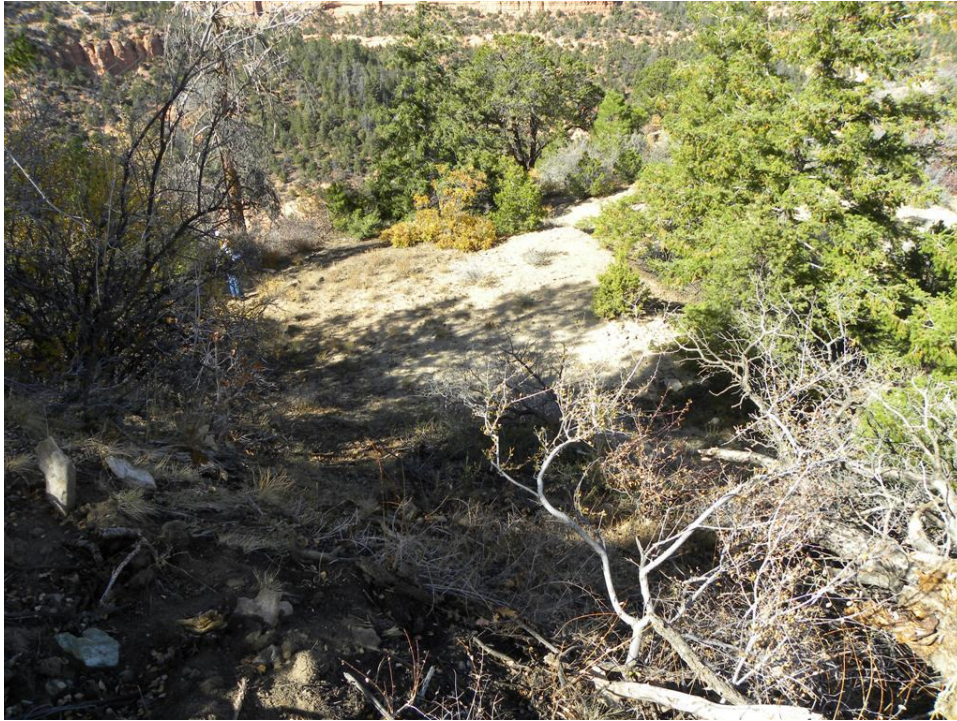
Photo 1. Pathway leading into mine site

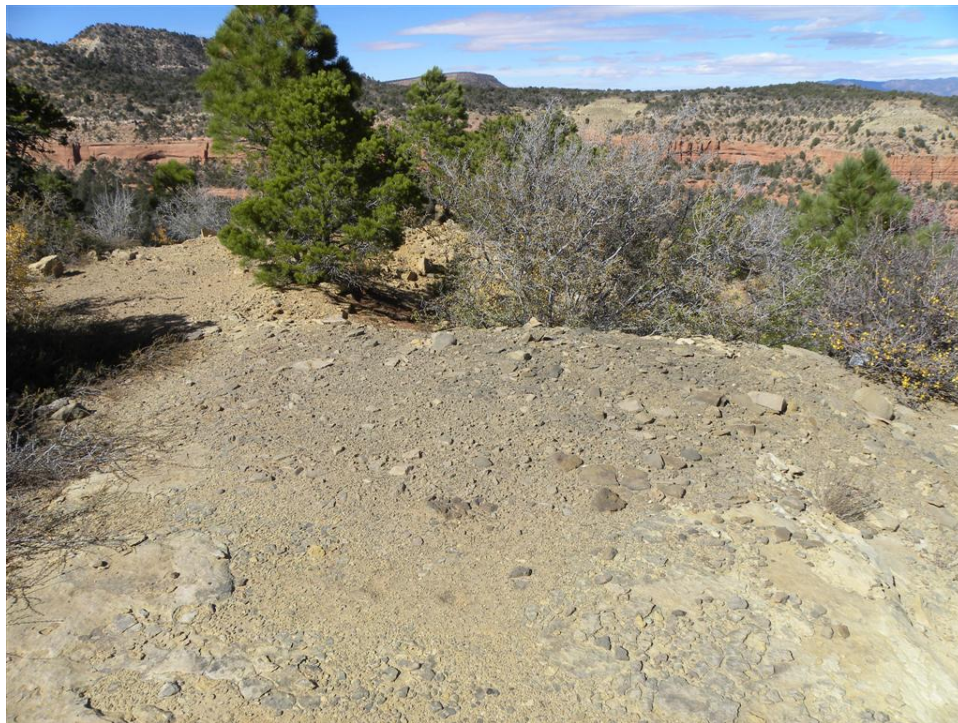
A total of 1,337 gamma radiation measurements were collected from the mine site, ranging from 7,536 cpm to 353,622 cpm. Measurements in the vicinity of the waste debris south of the site boundary were found at levels of approximately 160,000 cpm, and in the pile at the southern portion of the site at approximately 220,000 cpm. The measurements are represented in Figures 1 and 2.

Two debris piles observed approximately 80 ft apart: 5' x 15'; 5' x 20'; with a total estimated volume of 107 yd<sup>3</sup>

Photo3. Waste pile in southern portion of site
